DEPARTMENT OF THE ARMY
ARMY CONCEPT TEAM IN VIETNAM
APO San Francisco 96384

FINAL REPORT

MILITARY POLICE RIVER/HARBOR SECURITY COMPANY

ACTIV PROJECT No. ACG-73F

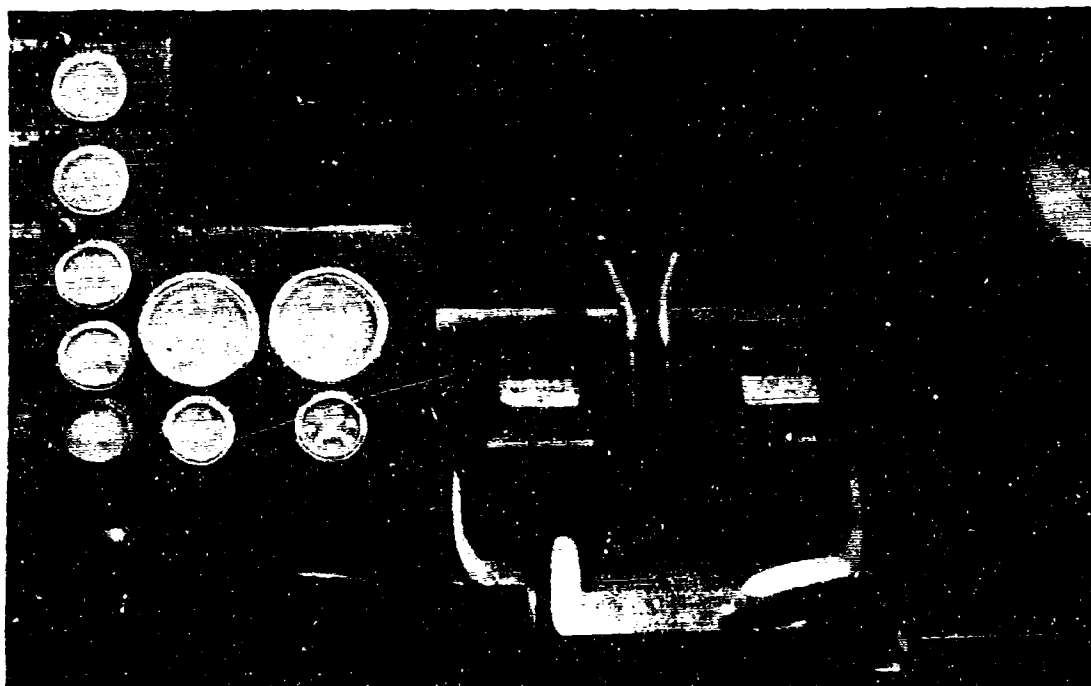
FIGURE II-12. Control Panel (Coxswain's Station).

The controls for the boat (see Figure II-12) were considered adequate by all personnel interviewed. Brighter control-panel lights for night illumination was the only change recommended. It was recommended that a higher wattage bulb with rheostat control be installed.

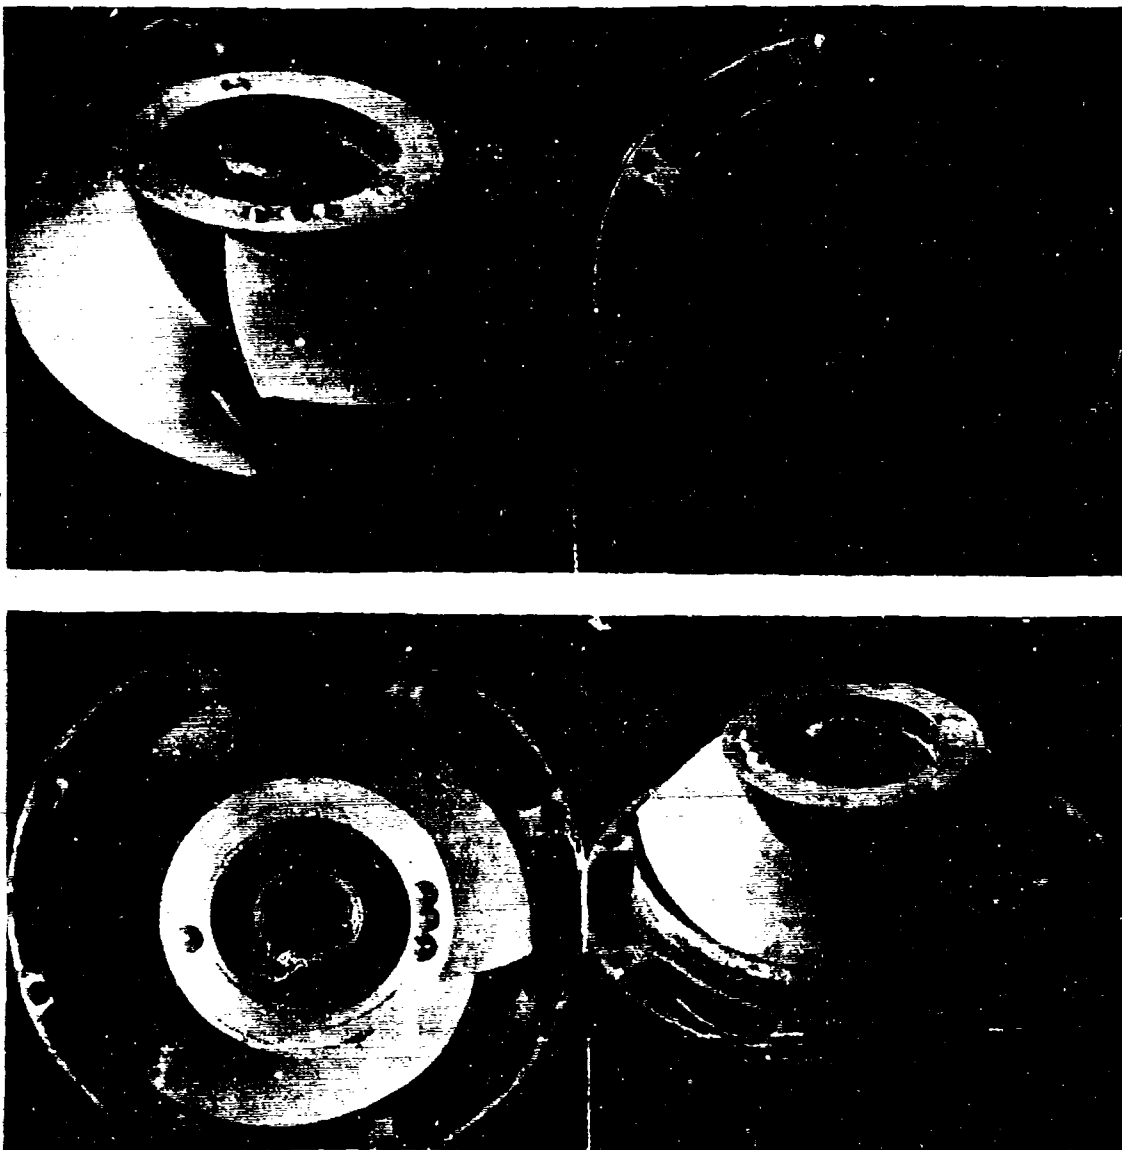
FIGURE II-37. MK2 Jacuzzi Pump Wear Plates With Impeller.

(a) Wear Plates, impellers, and bearings were the major causes of Jacuzzi pump failures. The stainless steel impellers and wear plates were susceptible to salt-water corrosion and pitting. Abrasive effects of silt and other foreign matter in the river water caused accelerated wear because special marine grease was not available.

(b) US Navy experiments revealed that wear plates made from a manganese/bronze alloy lasted much longer (an estimated four to eight times) than the standard stainless steel plates. A new stainless steel plate cost \$187.00, and a specially manufactured manganese/bronze plate cost \$250.00. Since requisition lead time on Jacuzzi pump parts was approximately 265 days, MMAV contracted for 20 locally manufactured manganese/bronze plates and found them to be more durable than the stainless steel wear plates (see Figures II-37 and II-38).
